Manhole Inspection Summary

Manhole # S45I__011MH

Insp Date: **4/25/08 9:27 AM**

Location Address: **18 21 s durham st**

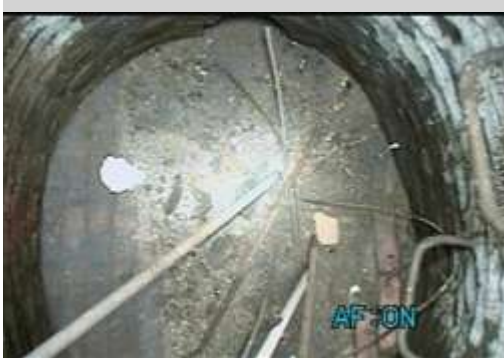
Defect 3

Condition: ☐ Sound ☐ Cracked ☐ Root Intrusion ☐ Deteriorated ☐ Leaks ☒ Debris

channel debris

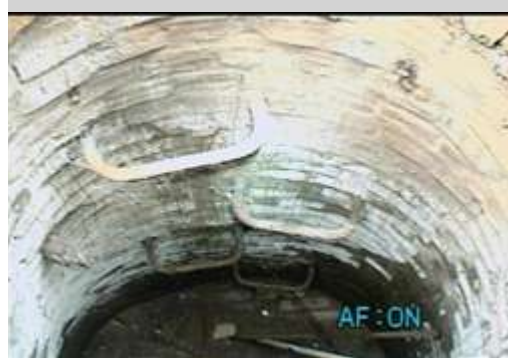
Defect 2

Condition: ☐ Sound ☐ Cracked ☐ Root Intrusion ☐ Loose Brick ☒ Deteriorated

Count: **4** Missing: **0** ☒ Corroded

corroded stairs & deteriorated barrel

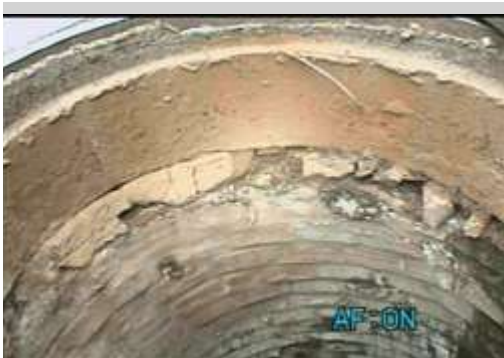
Defect 1

Condition: ☐ Sound ☐ Cracked ☐ Root Intrusion ☒ Loose Brick ☒ Deteriorated

frame adjustments deterioration and loose brick

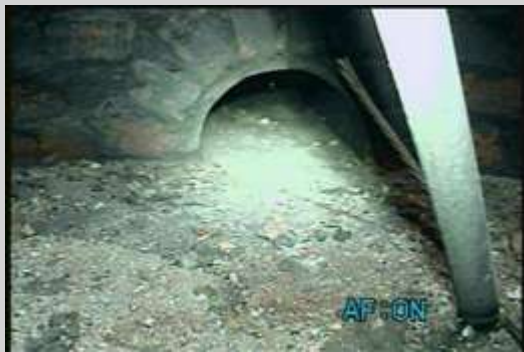
12 O'Clock Outflow

Deposits: ☐ None ☐ Mud ☐ Sludge ☒ **Debris** ☐ Grease

Silt Depth: **2** (in.) Deposits Extent: **Medium**
